New Life for the RA17

Rob Filby G0HJR describes how he worked on his RA17 receiver – restoring an old friend to its impressive full working order after many false starts!

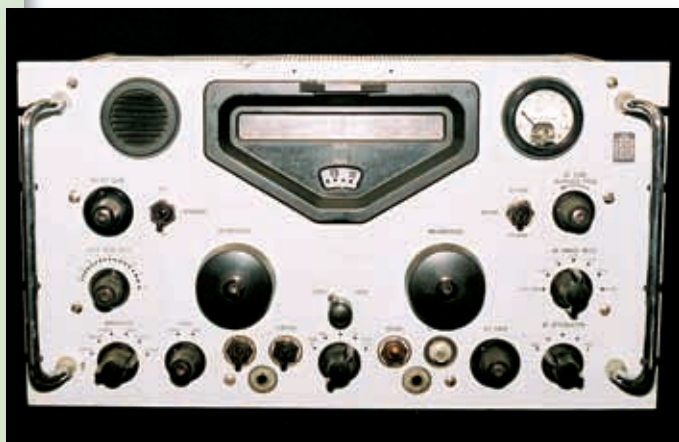
Front panel view of the Racal receiver.

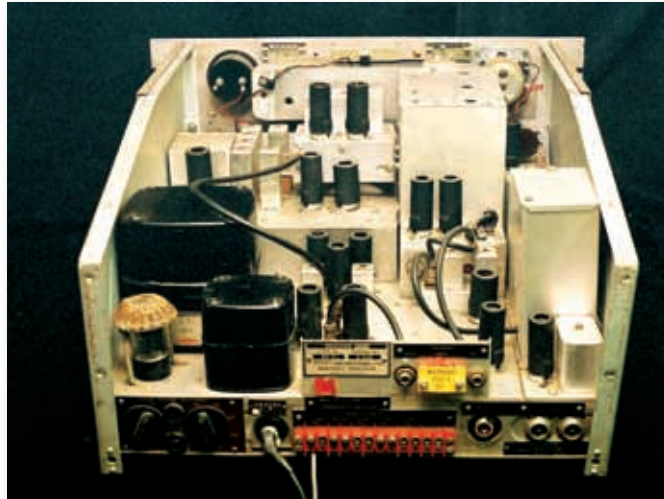
Inside view of the receiver, showing the substantial framing. (Photography courtesy of Ben Nock G4BXD).
